External Environmental Audit Report for the Vaal Waste Dump Site at the ArcelorMittal Vereeniging Works in Gauteng Province

Client: ArcelorMittal

Reference: MD2956TPRP1812100546

Project name: ArcelorMittal Vereeniging Works External Compliance Audits

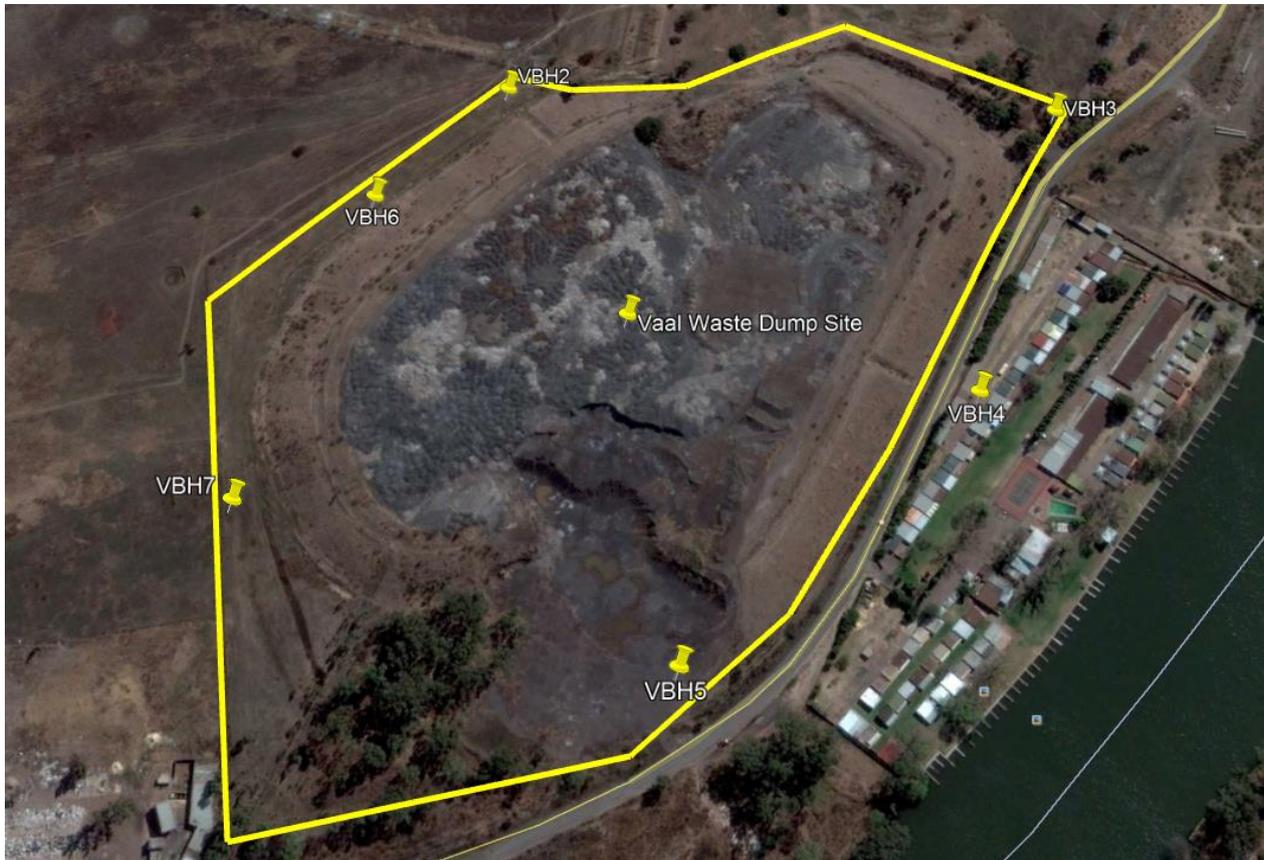
Figure 2: Locality of Boreholes at the Vaal Waste Site

The locations of the boreholes are shown in Figure 2 below.

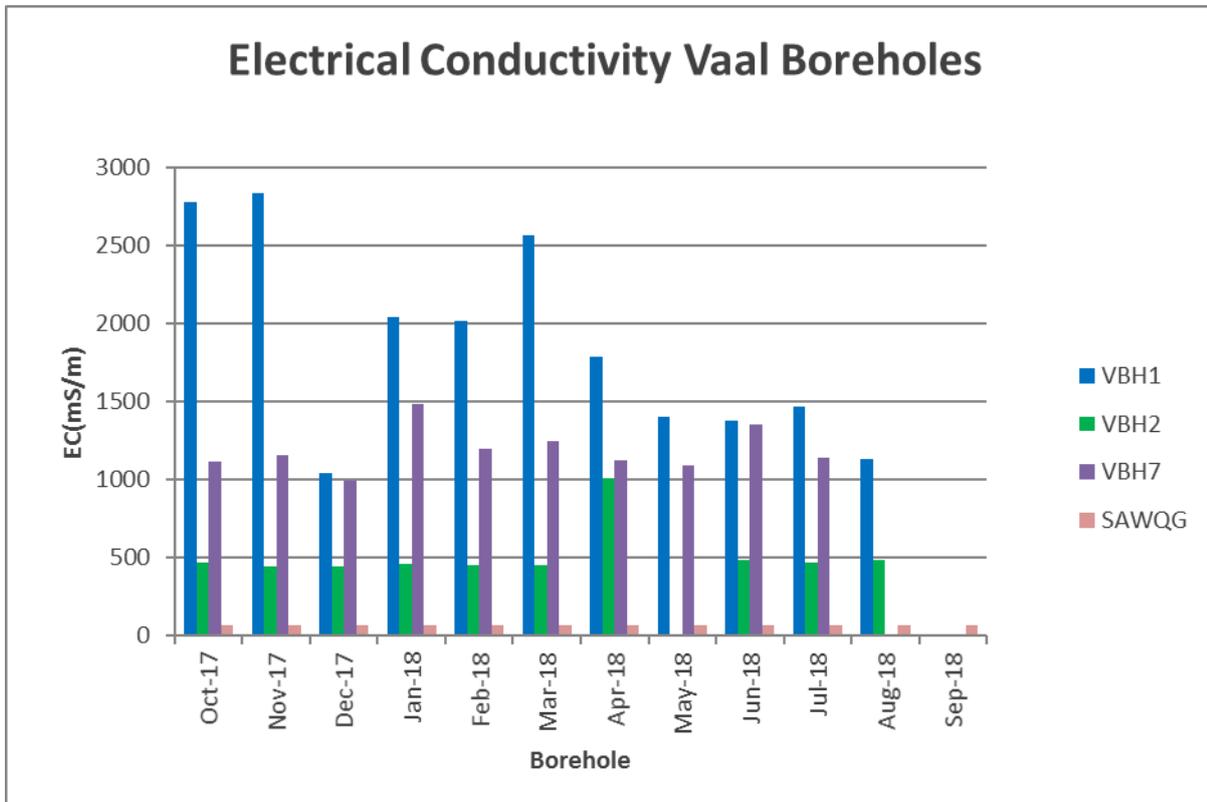
Figure 3: Electrical Conductivity measurements recorded at boreholes

The results from VBH2 were mostly stable, with an unexplained spike in April 2018. When cross-referencing to the Quarterly Report, the Auditor noted that no explanation was given and the values in Figure 1 in the report were in fact incorrect (based on the range depicted on vertical axis).

Total Dissolved Solids (TDS) displayed the same trend as EC.

2.	Variation of Compliance Notice (Item d)	The monitoring report submitted must reflect the monthly data collected in each monitoring borehole.	The EC results from VBH2 were mostly stable, with an unexplained spike in April 2018. When cross-referencing to the Quarterly Report, the Auditor noted that no explanation was given and the values in Figure 1 in the report were in fact incorrect (based on the range depicted on vertical axis). This seems to be the result of trying to combine EC and SO4 results on the same graph.	Low

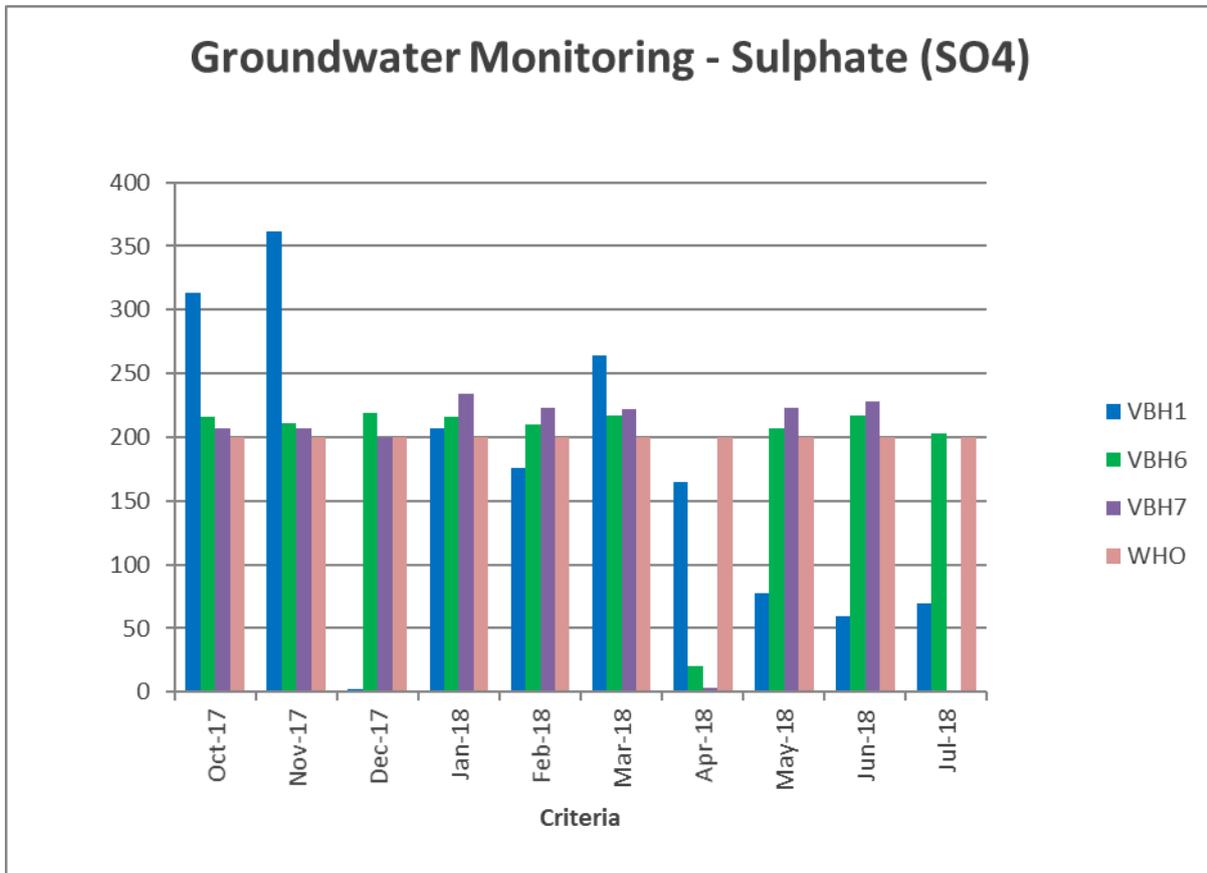
Figure 4: Sulphate measurements recorded at boreholes

The Auditor sampled used data from VBH1, VBH6 and VBH7; which are the three boreholes with elevated sulphate levels (in comparison to the other boreholes).

The period from October 2017 to March 2018 reflected a stable trend in sulphates; however, from April 2018 until September 2018 VBH1 (which is a downstream sample) sulphate levels decreased significantly.

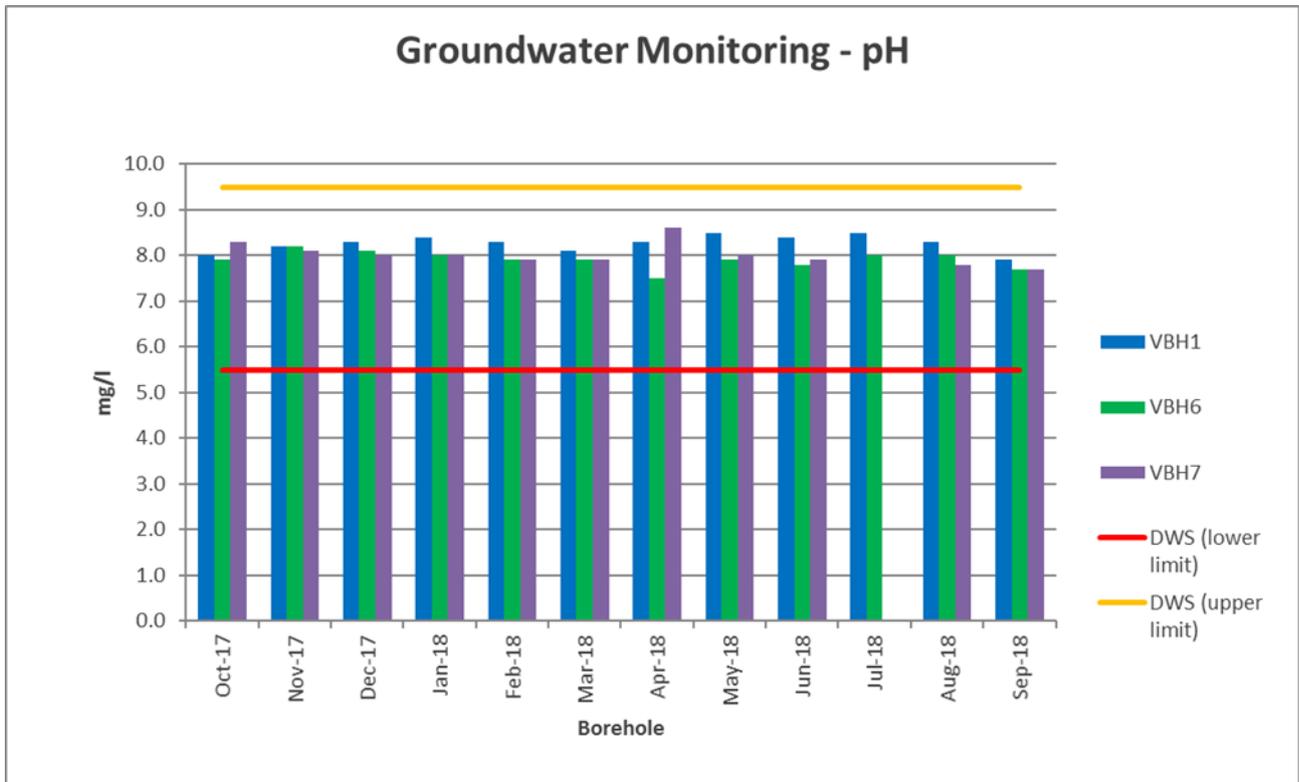
Figure 5: pH measurements recorded at boreholes

The Auditor sampled data from VBH1, VBH6 and VBH7. Based on the available data it is evident that pH levels fall within the compliance range as per Figure 5 (below).

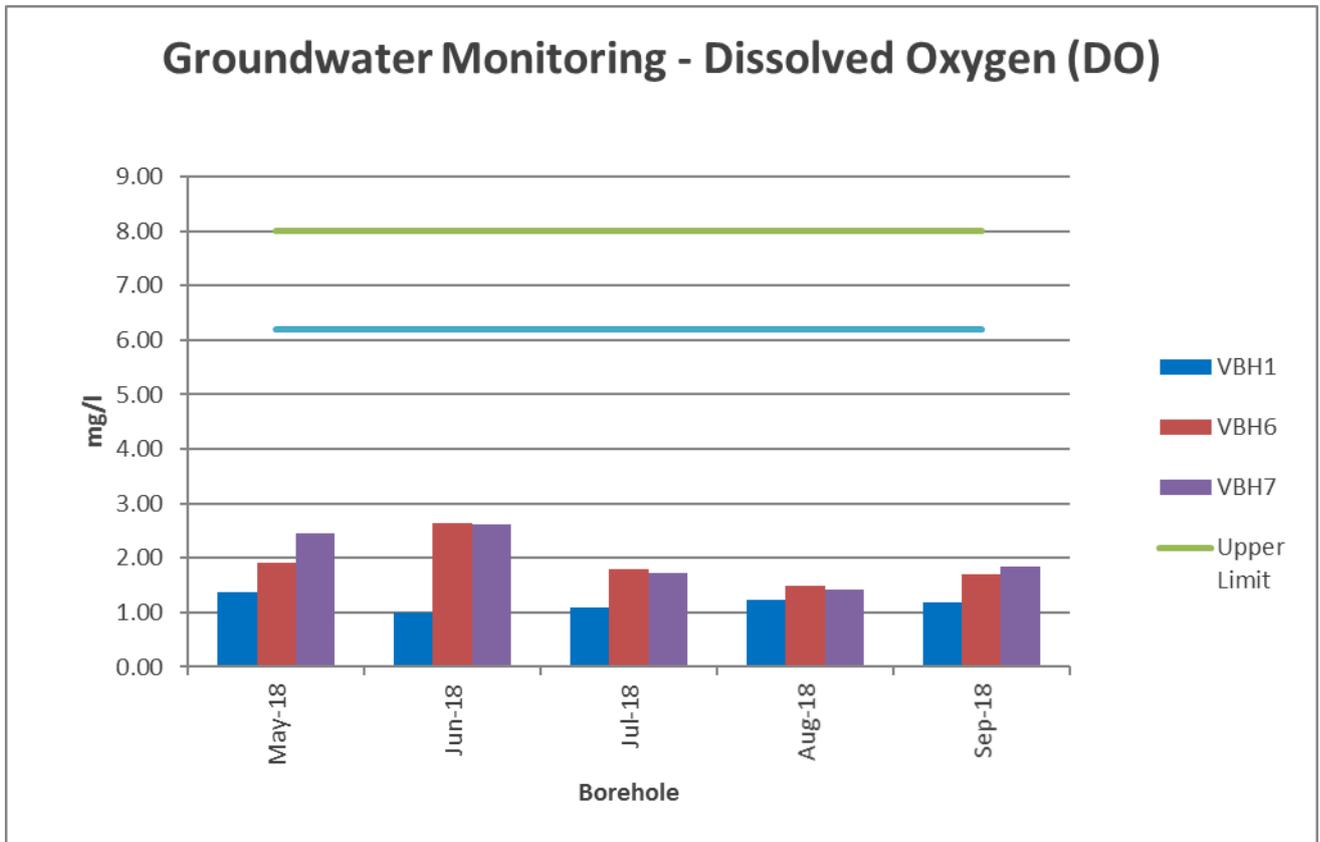
Figure 6: Dissolved Oxygen measurements recorded at boreholes

Data is therefore only available for the months May 2018 through to September 2018.

The Auditor sampled data from VBH1, VBH6 and VBH7, as per Figure 6 (below).

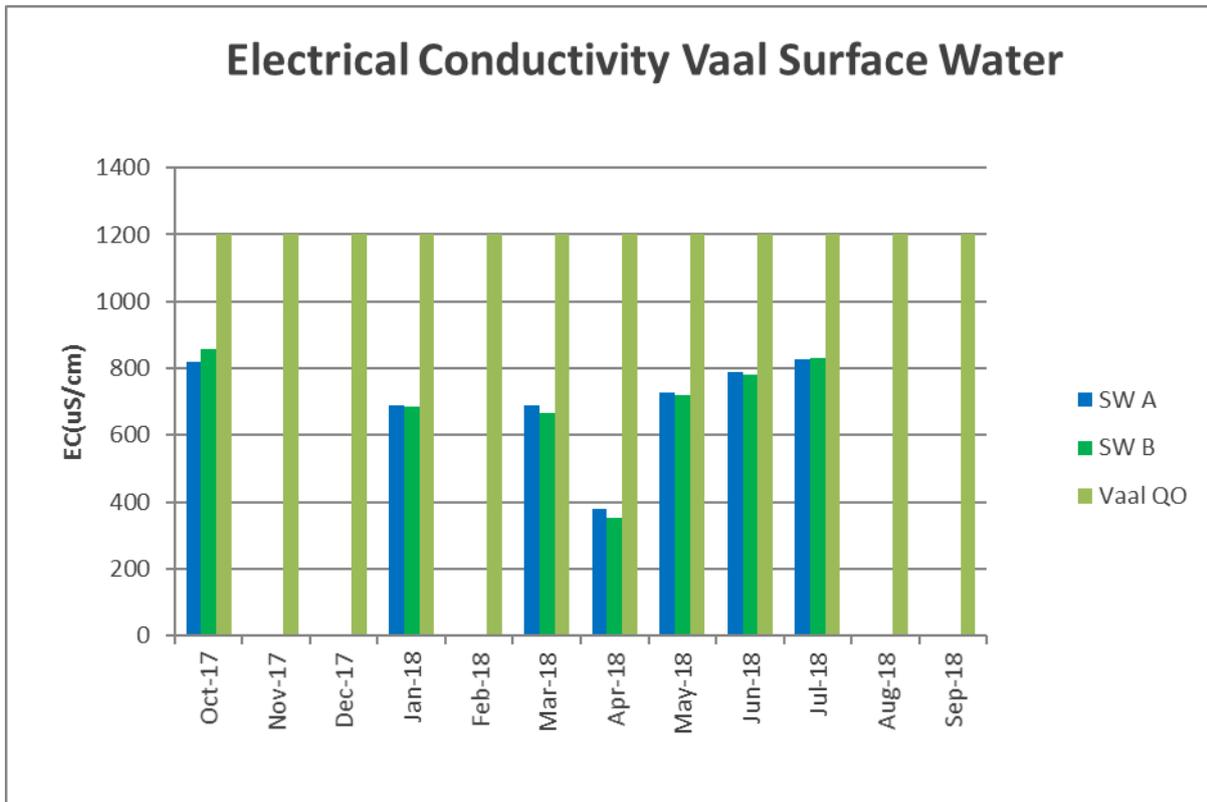
Figure 7: Electrical Conductivity measurements recorded at the Vaal River

No pollutants associated with the site have been detected thus far and neither have any water quality constituents such as Total Suspended Solids indicated any negative impacts on the river. The analysis of the sample data that were provided indicated no significant increase in EC up and downstream in the river adjacent to the site (see Figure 7 below). It is therefore confirmed that the impact of the site on surface resources are insignificant.

It must be noted that a number of data sets are missing. These include for the months of: November 2017, December 2017, February 2018 and August 2018.

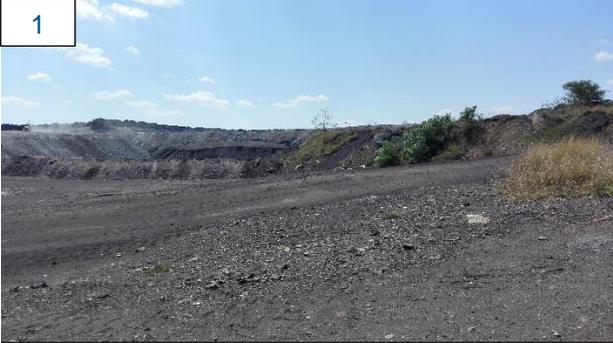
<p>General Observation</p> <p>Photo 1:</p> <p>The audit at AMSA’s Vaal Waste Dump Site was undertaken on Monday 29 October 2018 by Bjorn Hoffmann (as the Independent External Environmental Auditor).</p> <p>Auditees from AMSA included: Mr Sham Jagathlal And Mr Jeremiah Mnisi.</p> <p>AMSA were observed to be undertaken earthworks related to the Phase 2 Rehabilitation Works.</p>

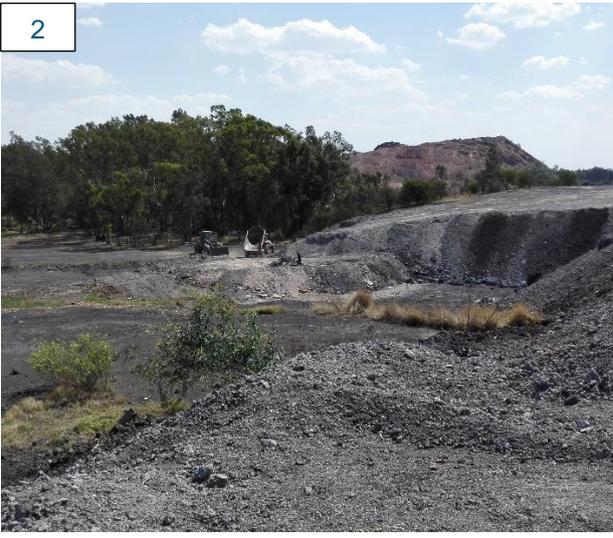
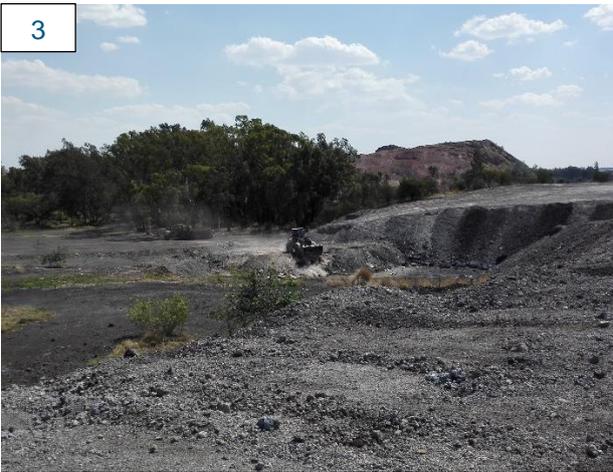
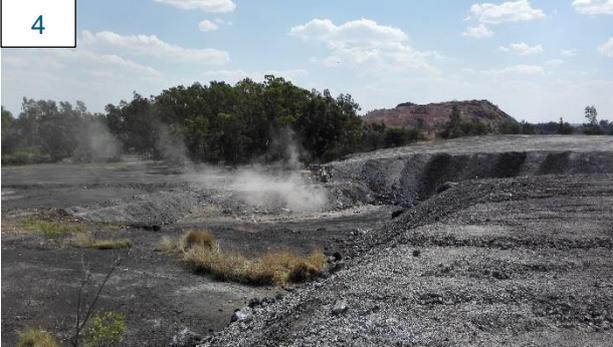
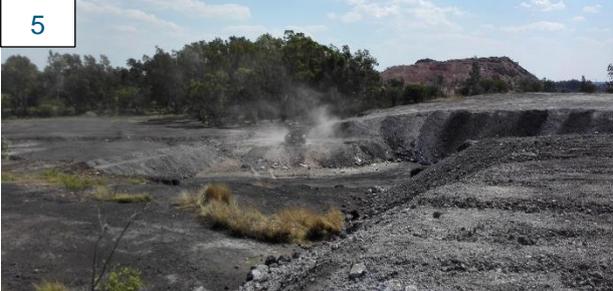
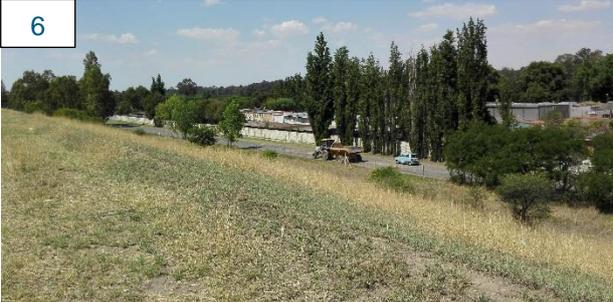
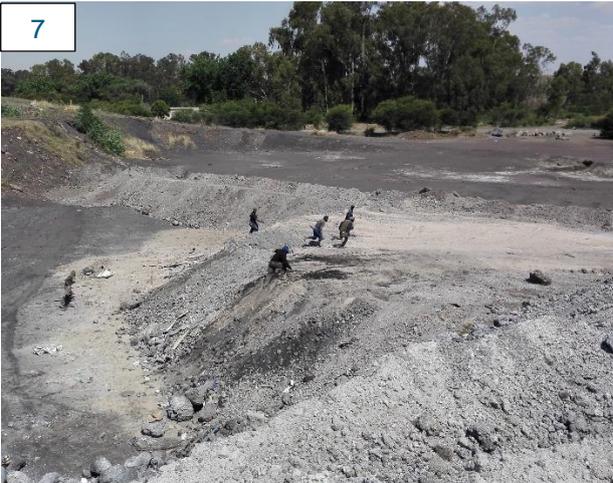
<p>Non-Compliance: Waste Management</p> <p>Photos 2 – 7:</p> <p>On the day of the audit, the Auditor observed that waste (rubble material including scrap metal) was being imported into the Vaal waste dump site by a tractor and trailer.</p> <p>The waste material was tipped from the trailer (Photo 2), pushed into the hole (where the magnetite was previously located) by the front end loader (Photo 3) and then covered over with material from the <i>in-situ</i> stockpile by the front end loader (Photos 4 & 5).</p> <p>Unauthorised local waste scavengers were on site and attempted to collect scrap metal as it was being tipped and covered over (Photo 7).</p>

<p>In follow up e-mail correspondence with Mr Sham Jagathlal of AMSA on 30 October 2018, it was confirmed that the finding on the day of the audit was not planned and was in fact strictly prohibited, and therefore was stopped immediately. It was admitted that there was some rubble tipped at the Vaal waste dump site that had been generated in the cleaning process at the meltshop as they prepared to re-open in January 2019. It was suggested that the Project Manager for Meltshop restart may have taken it upon himself to use the waste material as backfill.</p>

2.	EMPr (Section 2.5)	No site burying or dumping of any waste materials shall occur. The contractor shall provide a sufficient number of weatherproof bins, with lids, to store the solid waste produced on a daily basis. All the solid waste shall be disposed of at an approved landfill site	On the day of the audit, the Auditor observed that waste (rubble material including scrap metal) was being imported into the Vaal waste dump site by a tractor and trailer. The waste material was tipped from the trailer, pushed into the hole (where the magnetite was previously located) by the front end loader and then covered over with material from the in-situ stockpile by the front end loader. Unauthorised local waste scavengers were on site and attempted to collect scrap metal as it was being tipped and covered over. In follow up e-mail correspondence with Mr Sham Jagathlal of AMSA on 30 October 2018, it was confirmed that the finding on the day of the audit was not planned and was in fact strictly prohibited, and therefore was stopped immediately. It was admitted that there was some	High

<p>Mr Sham Jagathlal confirmed in a further follow-up e-mail (on the same day), that besides stopping the activity, AMSA will ensure all waste imported from the Meltshop will be removed and appropriately disposed of at a licenced landfill site.</p> <p>This finding is in non-compliance to the requirements of the EMPr that states: <i>No site burying or dumping of any waste materials shall occur</i> (Section 2.5 p5 of the approved EMPr).</p>

<p>The Auditor is of the opinion that AMSA acted responsibly by stopping an unplanned, unauthorised and previously unknown activities immediately. As long as proof of safe disposal of the imported material can be provided, in the form of weigh bridge slips, then the finding can be considered closed by the Department.</p>

<p>Additional environmental awareness training is also recommended for all staff involved with the Meltshop restart and Phase 2 Rehabilitation works at the Vaal Waste Dump Site. This training must include reminders about acceptable waste management practices and the consequences for any non-compliance to the requirements from the authorisations received from the Department.</p>

- (2) Proof of safe disposal of the imported material from the Meltshop restart must be provided to the Department (this in the form of weigh bridge slips from a licenced landfill site). Additional environmental awareness training is also recommended for all staff involved with the Meltshop restart and Phase 2 Rehabilitation works at the Vaal Waste Dump Site. This training must include reminders about acceptable waste management practices and the consequences for any non-compliance to the requirements from the authorisations received from the Department.

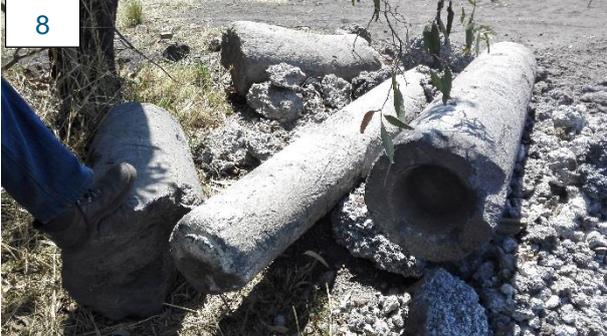
<p>8</p>	<p>General Observation: Waste Management</p> <p>Photo 8:</p> <p>Some re-usable and/ or recyclable waste is still being unearthed during the Phase 2 Rehabilitation Works. This includes the uncovering of anodes, as pictured.</p>

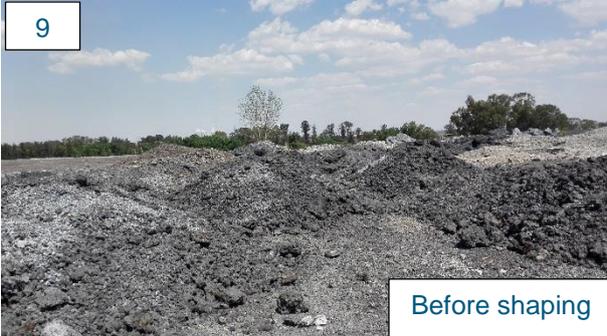
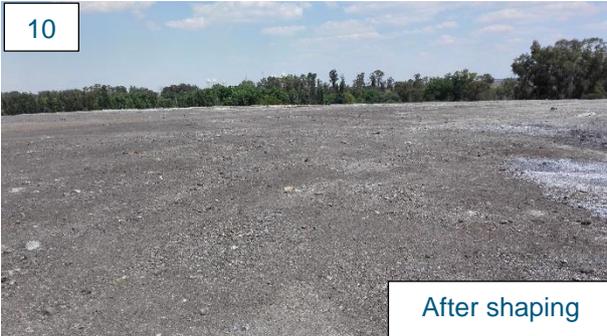
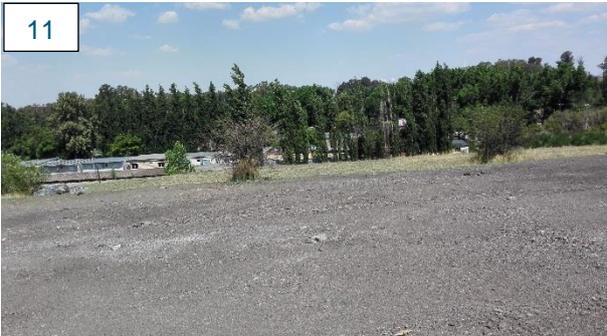
<p>9</p> <p>Before shaping</p>	<p>General Observation: Rehabilitation</p> <p>Photo 9:</p> <p>The rehabilitation and remediation process commenced in May 2018 as Phase 2 of the works. This includes shaping of the waste body to manage surface water, prior to capping.</p>

<p>10</p> <p>After shaping</p>

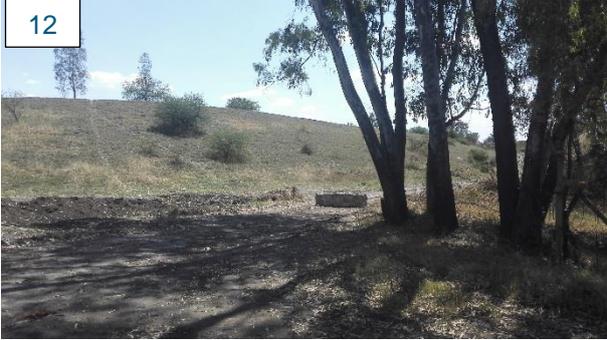
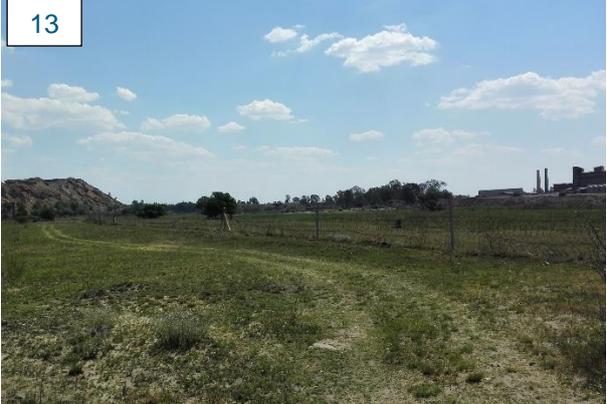
<p>Partial Compliance: Access Control</p> <p>Photos 12 & 13:</p> <p>AMSA has attempted to restrict access to the site in some areas by placing berms and excavating trenches along the perimeter of the site; this as gates and fencing is routinely stolen.</p> <p>According to the approved Amended Rehabilitation Plan, AMSA must erect a fence around the perimeter of the site, erect signs along the fence at intervals of no greater than 100m and regularly inspect fencing for any breach or damage.</p> <p>This finding has been noted as a partial compliance.</p>
<p>13</p>

3.	Amended Rehabilitation Plan (Section 5.1.1)	AMSA must erect a fence around the perimeter of the site, erect signs along the fence at intervals of no greater than 100m and regularly inspect fencing for any breach or damage.	AMSA has attempted to restrict access to the site in some areas by placing berms and excavating trenches along the perimeter of the site; this as gates and fencing is routinely stolen.	Medium

- (6) AMSA must utilise SANAS accredited laboratories for each water quality parameter that is required to be tested.
- (7) It is recommended that quarterly monitoring reports submitted to the Department accurately reflect the monthly data collected in each monitoring borehole. It is also recommended that the monitoring data be interpreted by a geohydrologist.
- (8) AMSA must erect a fence around the perimeter of the site, erect signs along the fence at intervals of no greater than 100m and regularly inspect fencing for any breach or damage.

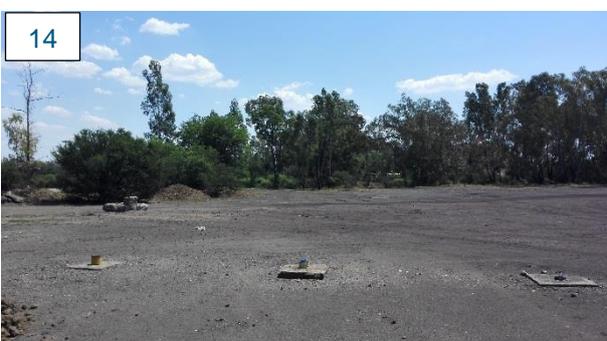
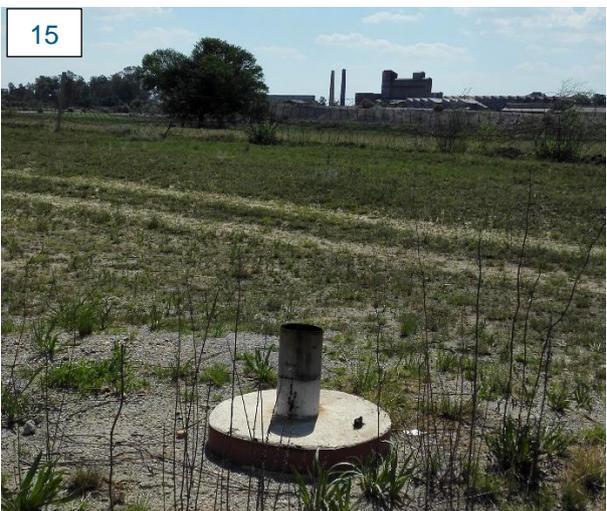
<p>Partial Compliance: Borehole Monitoring</p> <p>Borehole monitoring is currently being undertaken on a monthly basis. Significantly high contamination of groundwater was found when comparing upstream and downstream borehole results. Remediation of the site will greatly reduce any impacts and contamination of the groundwater.</p> <p>It is recommended that this groundwater contamination be reported to DWS in terms of Section 19 of the National Water Act.</p> <p>Findings related to:</p> <p>(1) although AMSA undertake all the monitoring of ground water as required by the Variation of the Compliance Notice; only two (2) parameters are analysed at a laboratory using a SANAS accredited methodology; these are Iron (Fe) and Chromium (Cr).</p> <p>The remaining elements, namely: Silver (Ag), Lead (Pb), Total Dissolved Solids (TDS) and Dissolved Oxygen (DO), are specifically excluded in the SANAS Schedule of Accreditation for the respective laboratories; and</p> <p>(2) The EC results from VBH2 were mostly stable, with an unexplained spike in April 2018. When</p>

Photos	Description
	<p>cross-referencing to the Quarterly Report, the Auditor noted that no explanation was given and the values in Figure 1 in the report were in fact incorrect (based on the range depicted on vertical axis).</p> <p>This seems to be the result of trying to combine EC and SO4 results on the same graph.</p> <p>These findings have been noted as partial compliances.</p>
<div data-bbox="199 824 279 875" style="border: 1px solid black; padding: 2px; width: fit-content;">16</div>

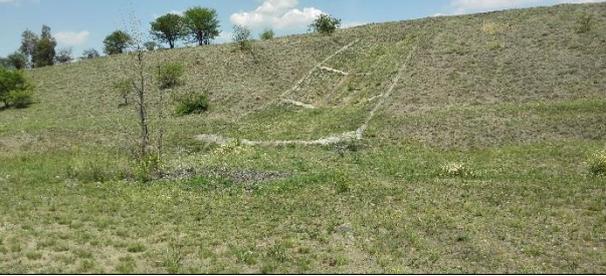
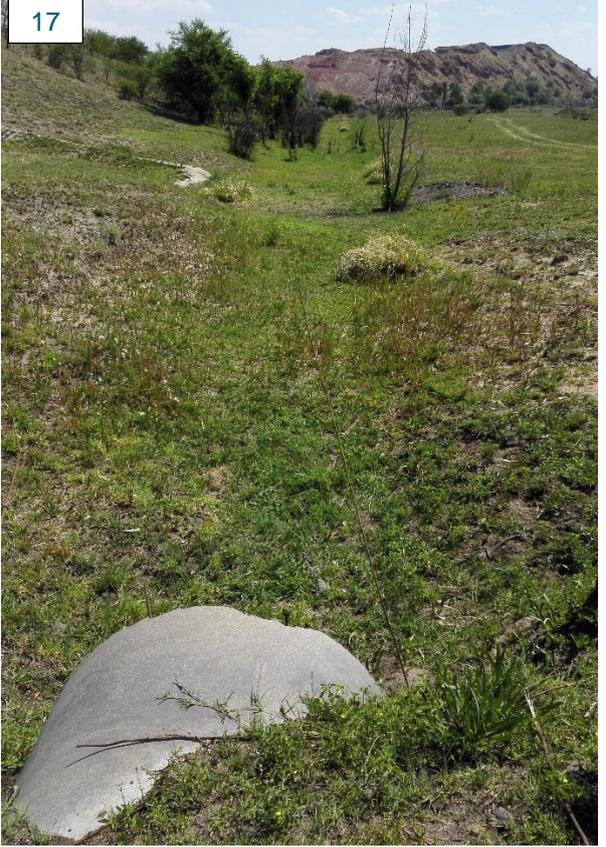
During the site audit it was noted that the side slopes of the disposal site have been successfully capped and vegetated with proper storm water controls being implemented. No erosion was noted and it was evident that the side slopes are in a stable condition. It was also noted that the vegetation had established itself effectively resulting in successful management of runoff by the storm water drainage system.

<p>General Observation: Stormwater Drainage and Water Channel</p> <p>Photos 16 & 17:</p> <p>Sufficient and effective stormwater drainage and water channels were noted to have been installed throughout the site.</p>
<div data-bbox="199 1176 279 1227" style="border: 1px solid black; padding: 2px; width: fit-content;">17</div>

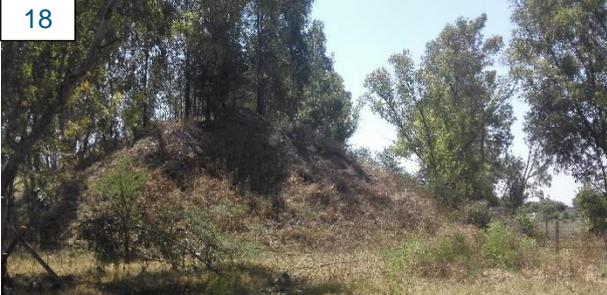
<p>General Observation: Success and Stability of Capping Layers</p> <p>Photo 18:</p> <p>Capping material has been stockpiled on site (as pictured).</p> <p>The capping of sideslopes has been completed and these are stable (refer to Photo 16 above).</p>
<p>19</p>

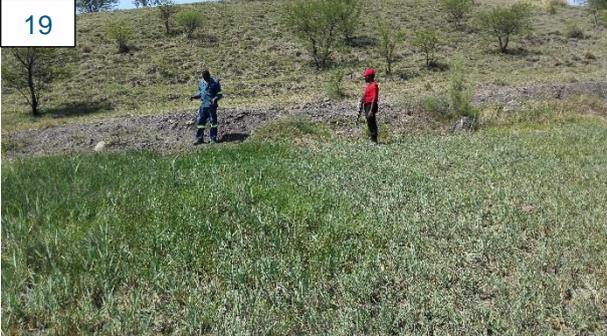
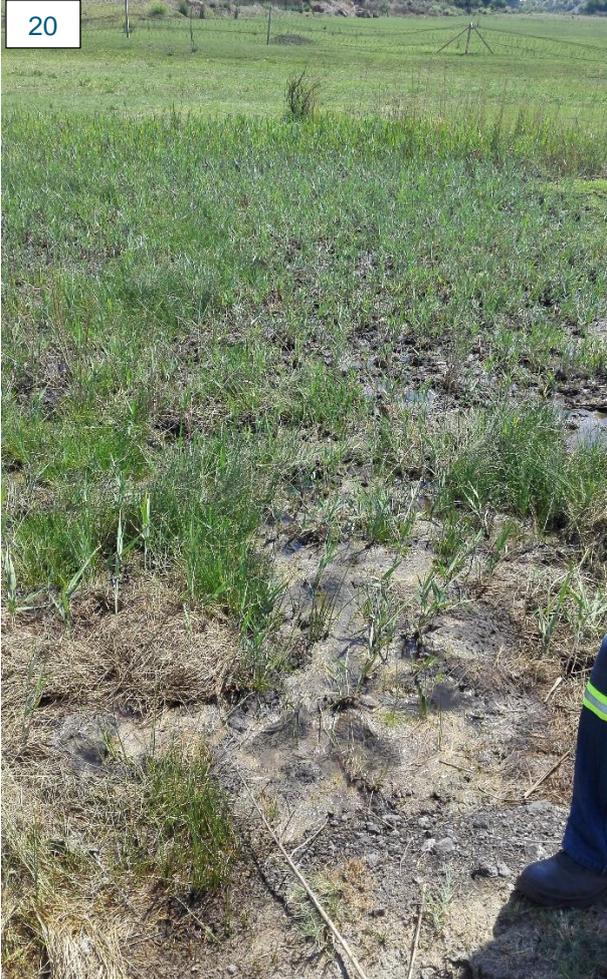
<p>General Observation: Seepage/ Leachate</p> <p>Photos 19 & 20:</p> <p>On the day of the audit some leachate was visible; however, no monitoring results are available for the current reporting period.</p> <p>AMSA claim that there is not enough leachate available on any given day to sample.</p> <p>The representative from AMSA indicated to the Auditor that this matter has been raised with the Department (GDARD) and is in the process of being discussed to find a viable solution. It is recommended that a viable solution is agreed upon by both parties (i.e. AMSA and GDARD). The Auditor is however of the opinion that remediation of the site will assist with the reduction of contamination.</p>

The representative from AMSA indicated to the Auditor that this matter has been raised with the Department (GDARD) and is in the process of being discussed to find a viable solution. It is recommended that a viable solution is agreed upon by both parties (i.e. AMSA and GDARD). The Auditor is however of the opinion that remediation of the site will assist with the reduction of contamination.
