**EXTERNAL AUDIT REPORT IN FULFILMENT
OF THE ENVIRONMENTAL AUTHORISATION
FOR THE
METALLURGICAL WASTE DISPOSAL SITE
AT
ARCELORMITTAL SOUTH AFRICA
VANDERBIJLPARK WORKS**

Report Nr: 677-ZANAMSA- 2017

Audit date: 23 March 2017

| Report Name: | External Audit Report for the old Metallurgical Waste Disposal Site in terms of the Environmental Authorisation (ROD). |

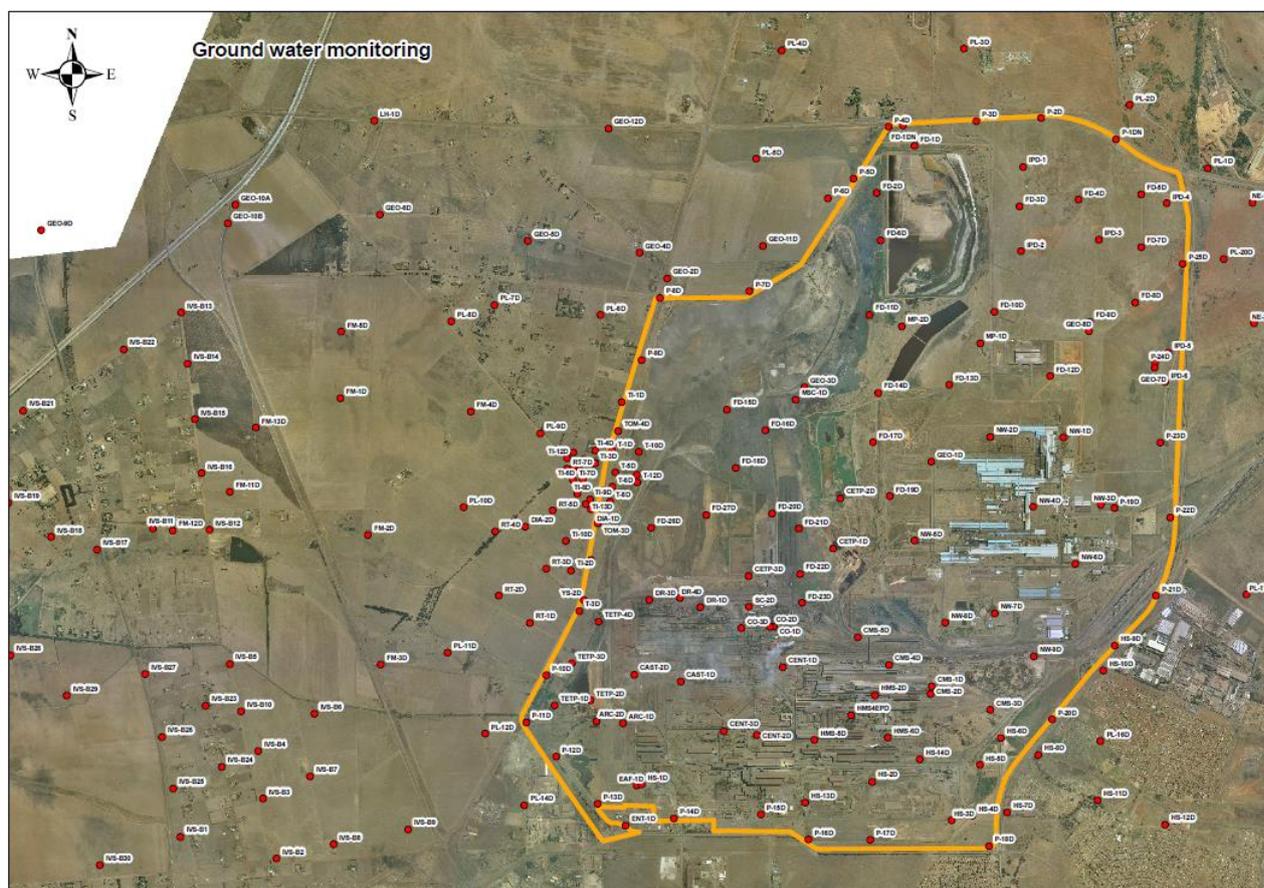
Figure 1: Locations of all existing boreholes

ArcelorMittal Vanderbijlpark Works has an extensive ground water monitoring network as can be seen from the aerial photograph below.

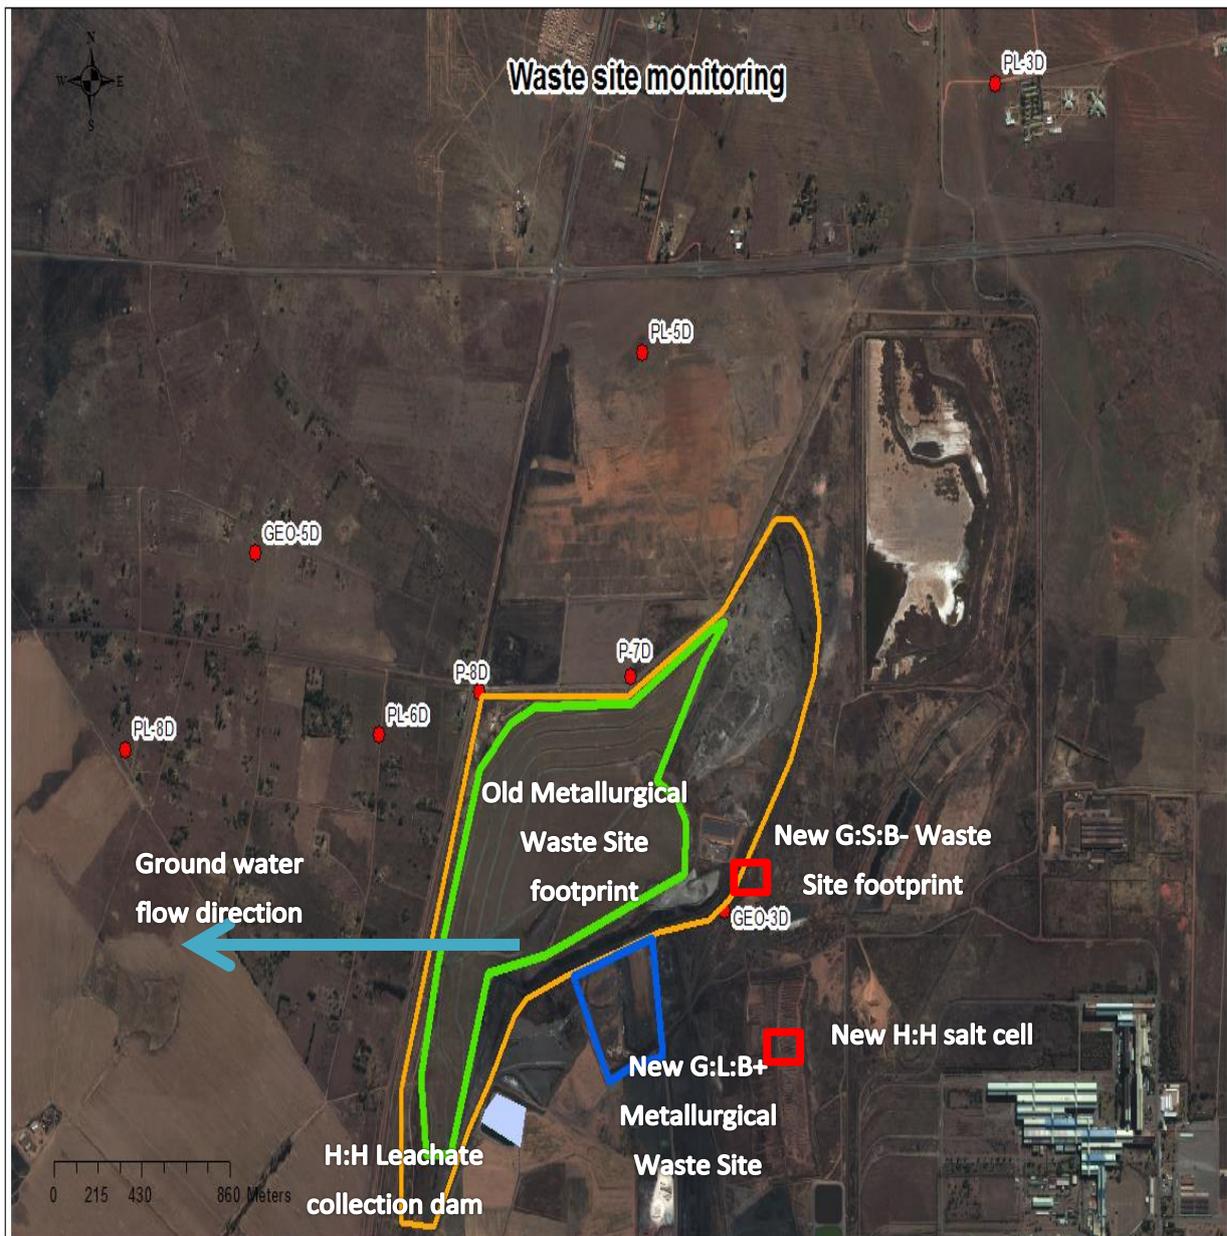
Figure 2: Boreholes chosen for monitoring waste impacts

The remaining boreholes listed can all be considered as downstream boreholes from the overall waste management activities on site. The location of the boreholes is indicated in the aerial photograph in relation to the different waste management facilities.

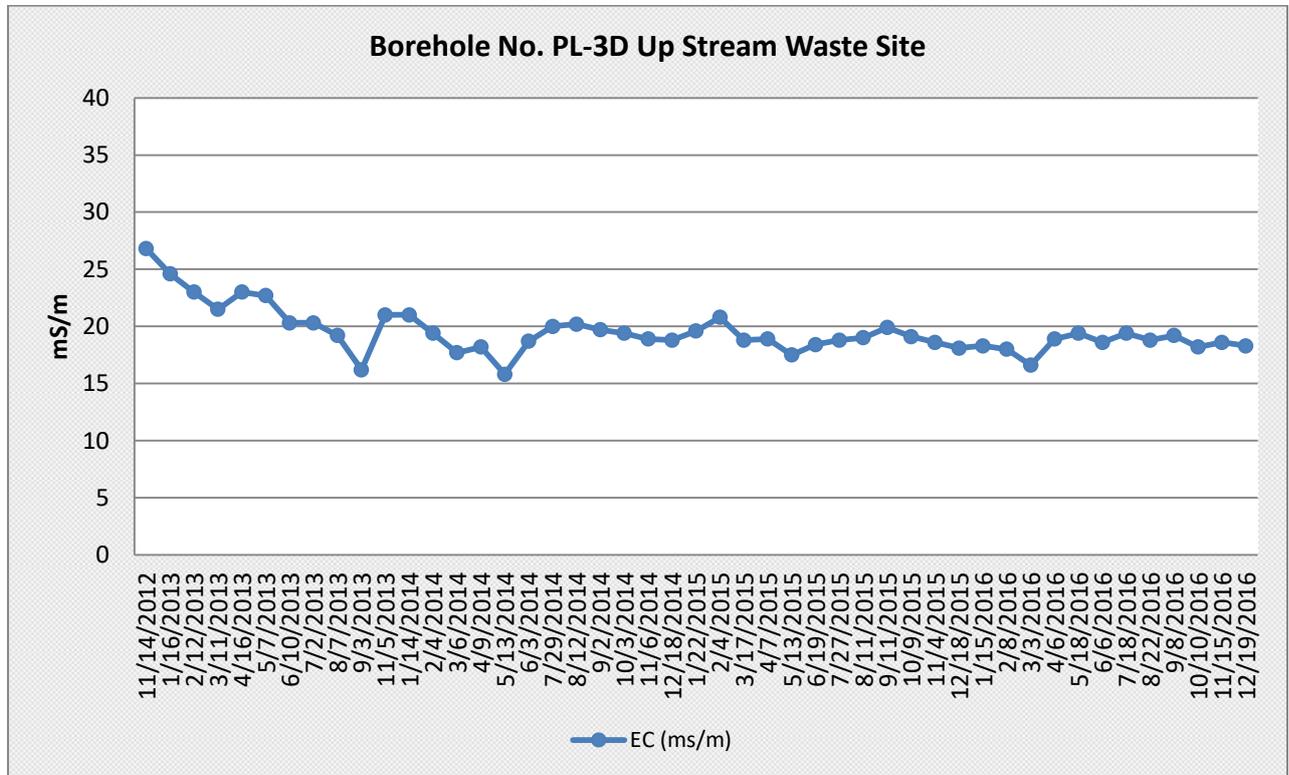
Figure 3: PL-3D upstream

When considering the ground water monitoring results upstream of the waste disposal site facilities, borehole PL-3D are the correct borehole to use, considering that there is a ground water divide between the eastern and western section of the site. The Electric Conductivity is used as an indicator tool to determine if a flag should be raised. When the EC exceeds 150 mS/m, the element is considered elevated from background levels or exceeding Drinking Water standards Class 1. It does not mean that the ground water then has an unacceptable impact as there is no ground water users at the specific location, but must only be used as an indicator tool or screening level 1.

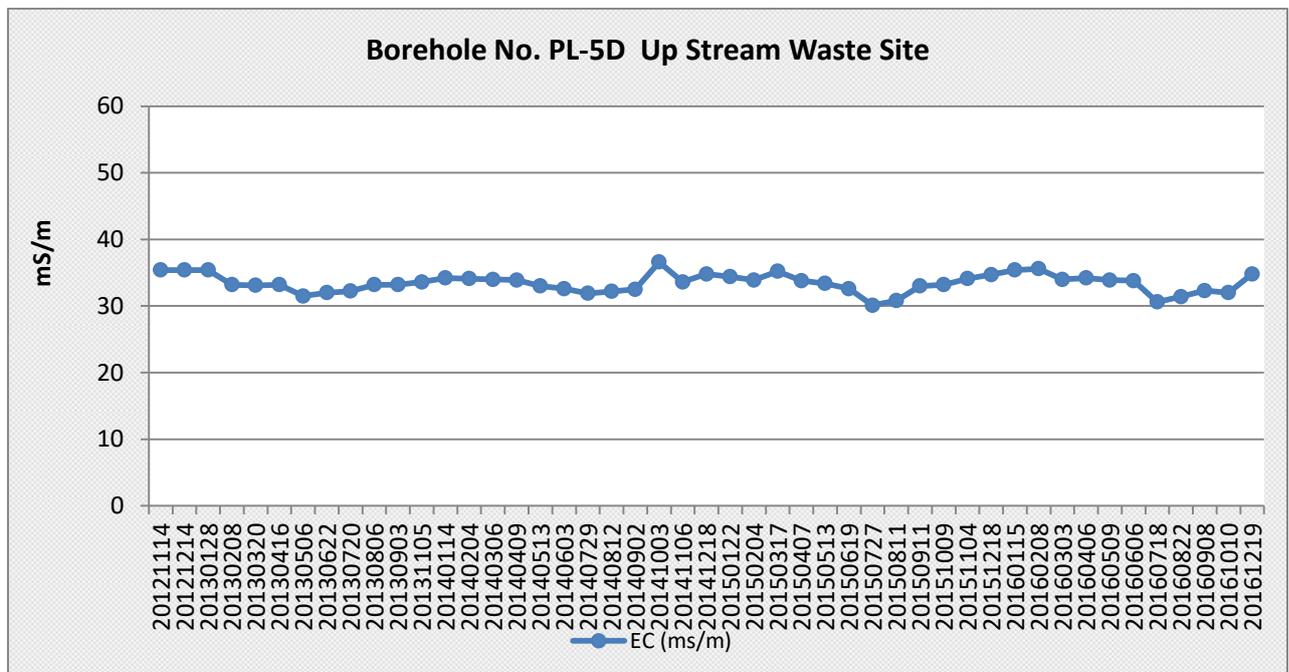
Figure 4: PL-5D Electric Conductivity

Borehole PL-5D is not within the ground water flow path of the waste site impacts, but is included in the trended results to be used as a back ground indication. The borehole is however located in its own stream

of other activities. The impact on the ground water in this region has previously been noticeable but acceptable, and that the contaminant plume has indicated an improved ground water quality. The figured below indicate the EC trend measured in the borehole since the construction and operation of the new waste site facilities.

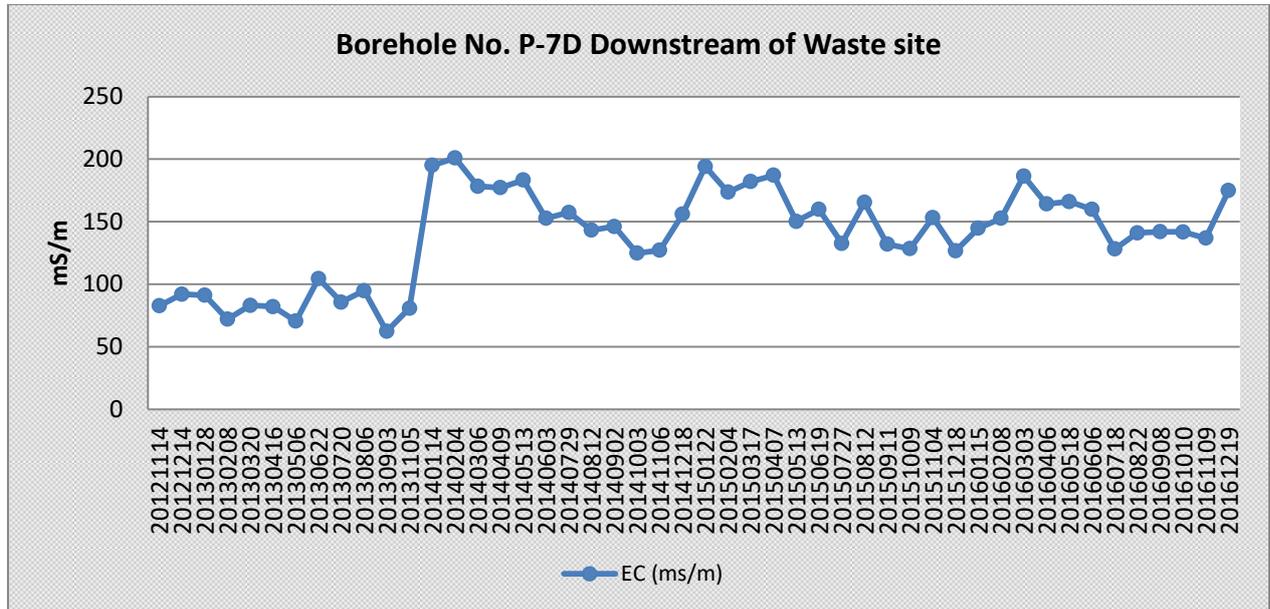
Figure 5: P7-D Electric Conductivity

P7D, P8D and P9D (Figure 5, 6 and 7 below) are on the edge of the western boundary of the old Metallurgical waste site. The impact therefore of the previous site (the Metallurgical) is demonstrated by

these boreholes. The elements that are elevated in this area are mostly Calcium, Magnesium, Chlorides and Sulphates.

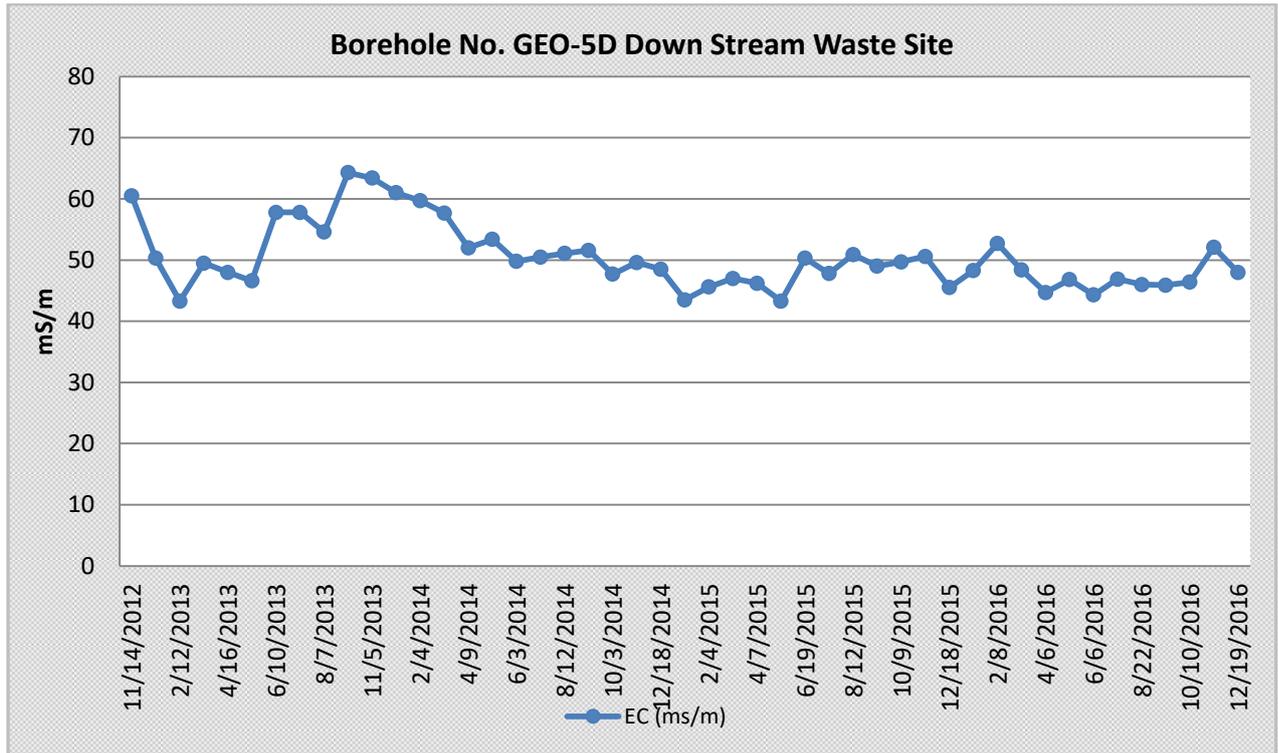
Figure 7: GEO 5D Electric Conductivity

Monitoring boreholes PL 6, GEO-5D, PL-8D (figure 7 and 8) indicates the impact about 500 meters from the old waste site boundary.

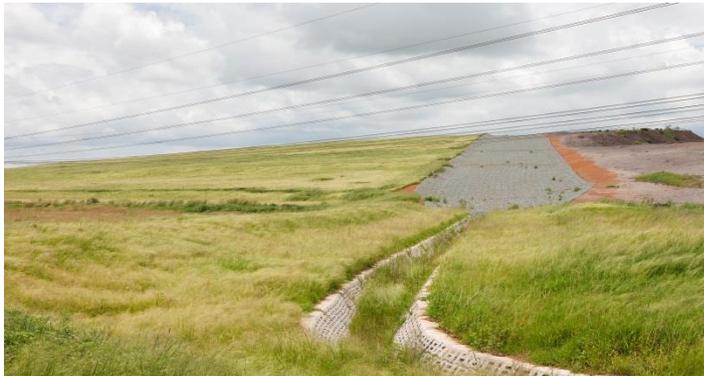
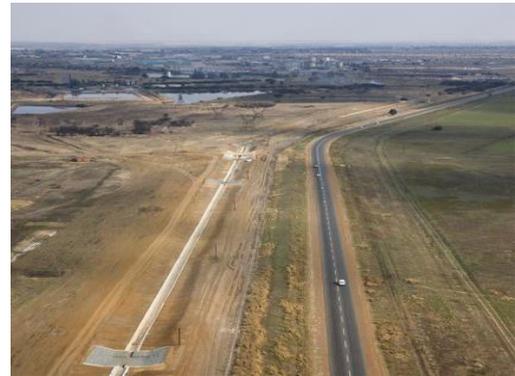
Photo 1 and 2 Storm water run off canal

ArcelorMittal conduct storm water quality monitoring at the down chute of the old waste site and the leachate dam. The down chute was constructed so that it channels all the runoff water quality from the remediated areas to the storm water discharge point. The run off water quality is measured on an ad hoc basis after a rain event at the down chute, and is of a good quality and complies in all aspects to a Class 0 (Ideal range) drinking water standard before it combines with other storm water canals for discharge.

The site is sloped and shaped during remediation in order for the run off water to all collect at the down chute and then flow via the canal on the western boundary of the works until it joins the storm water network for the works before discharge.

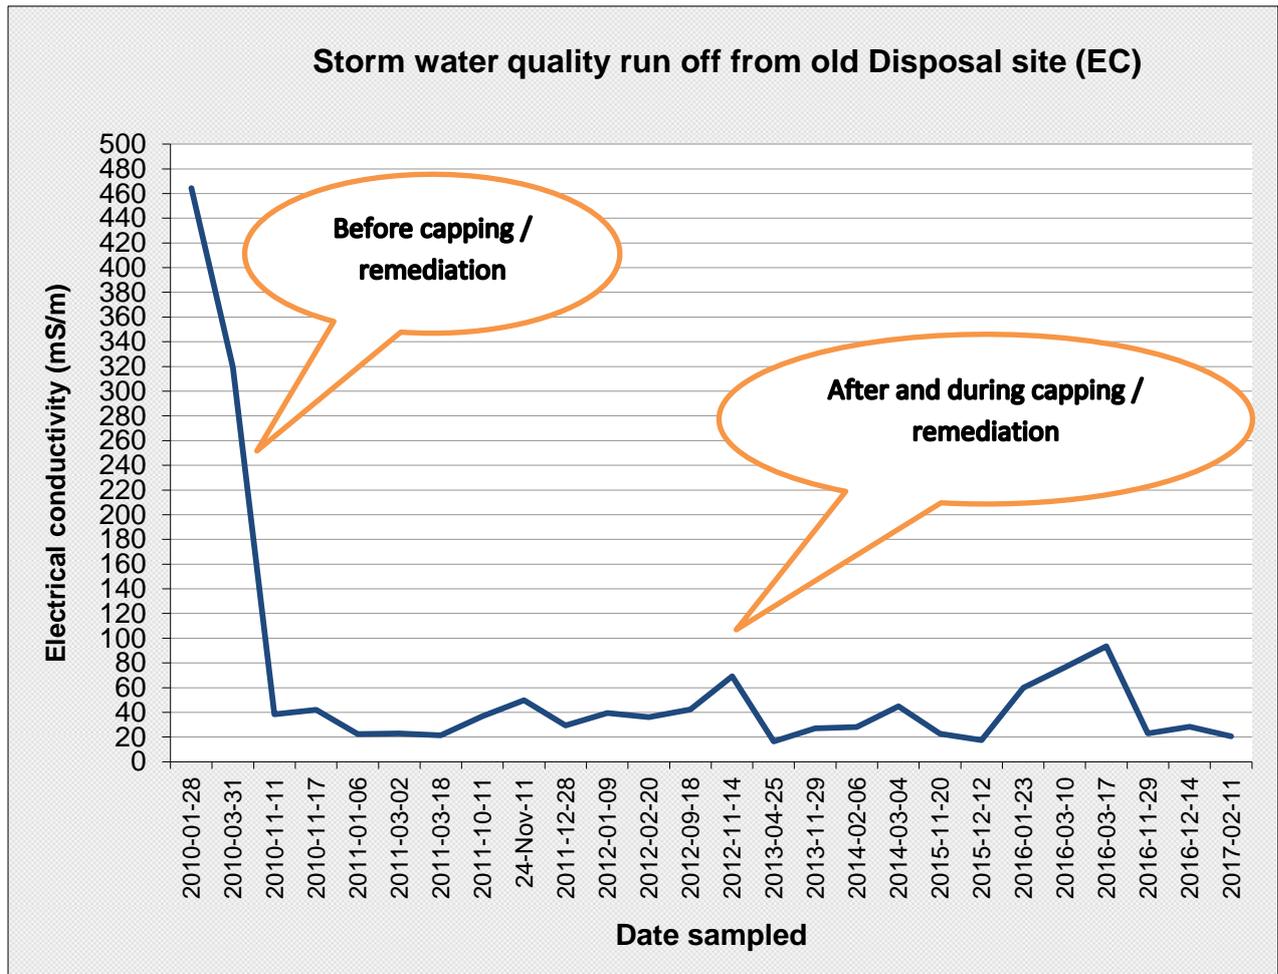
Figure 9: Storm water quality at the old waste site prior to and after remediation

The remediation of the old Metallurgical waste site has therefore had a very positive impact on the run off quality from the site.

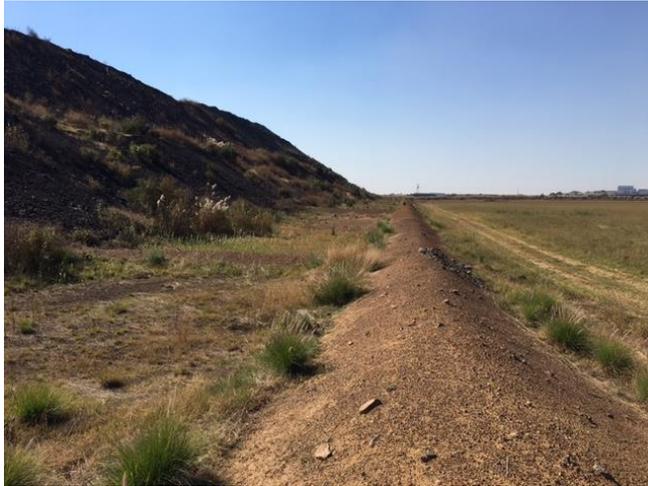
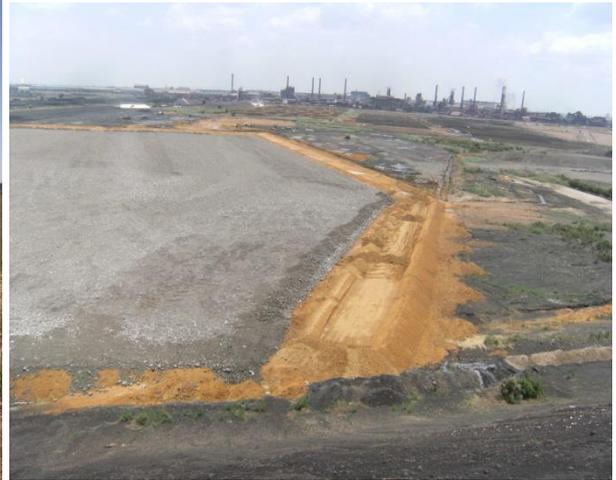
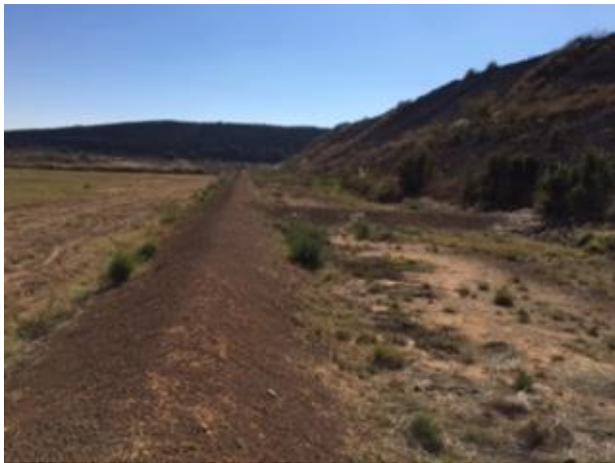
Photo 3, 4 & 5 Paddocks at Metallurgical Site

The new Dry Metallurgical waste disposal site has been constructed with a paddock system to capture all contaminated run off which is captured and diverted into the leachate collection system. The leachate collection system is gravity fed into the H:H Leachate dam.

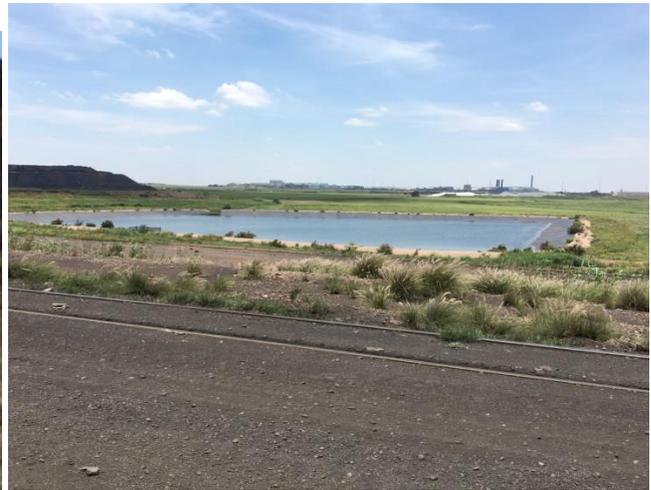
Photo 6: H:H Leachate Dam

Leachate water from various waste related activities is diverted to the leachate collection dam but the metallurgical waste sites contribution would be the most. The volume and quality of the leachate is measured. The facility has the infrastructure to pump and treat the leachate captured at Main Treatment Plant (MTP) but to date the levels of the leachate control dam did not necessitate this. The evaporation rate exceeds the inflow of leachate into the dam.

(Contaminated runoff collection)

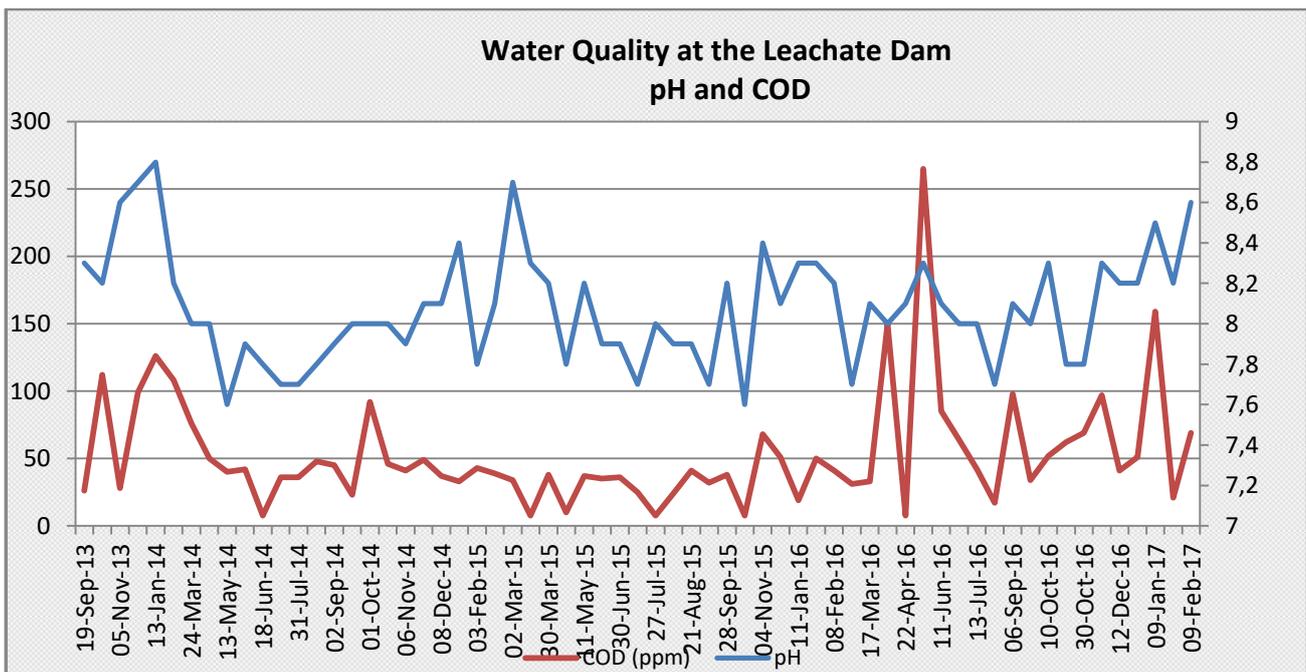
Figure 10: Leachate dam pH and the Chemical Oxygen Demand (COD) levels

During the site visit the leachate dam volumes indicated therefore that the capacity remains below 55% of the maximum and therefore does not pose a risk to overflow. The quality of the leachate water fluctuates as expected as more and more water is evaporated and the salt concentration builds up.

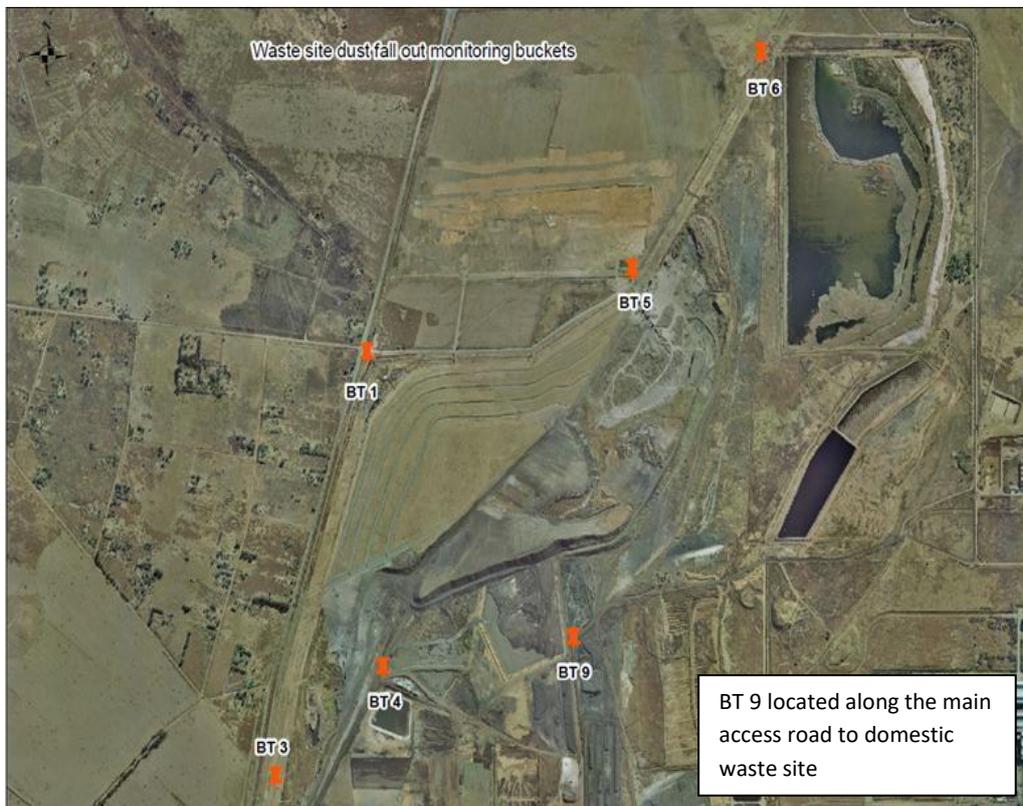
Figure 15: Position of Waste Site Dust Fall out Buckets

The amount of exceedences was assessed as there was enough data available to make such observations. The data availability of the stations is more than 80% and the facility has improved their monitoring system. As part of the air quality monitoring network, the facility also monitors the dust fall out levels around the waste disposal site facilities at the locations as indicated below.

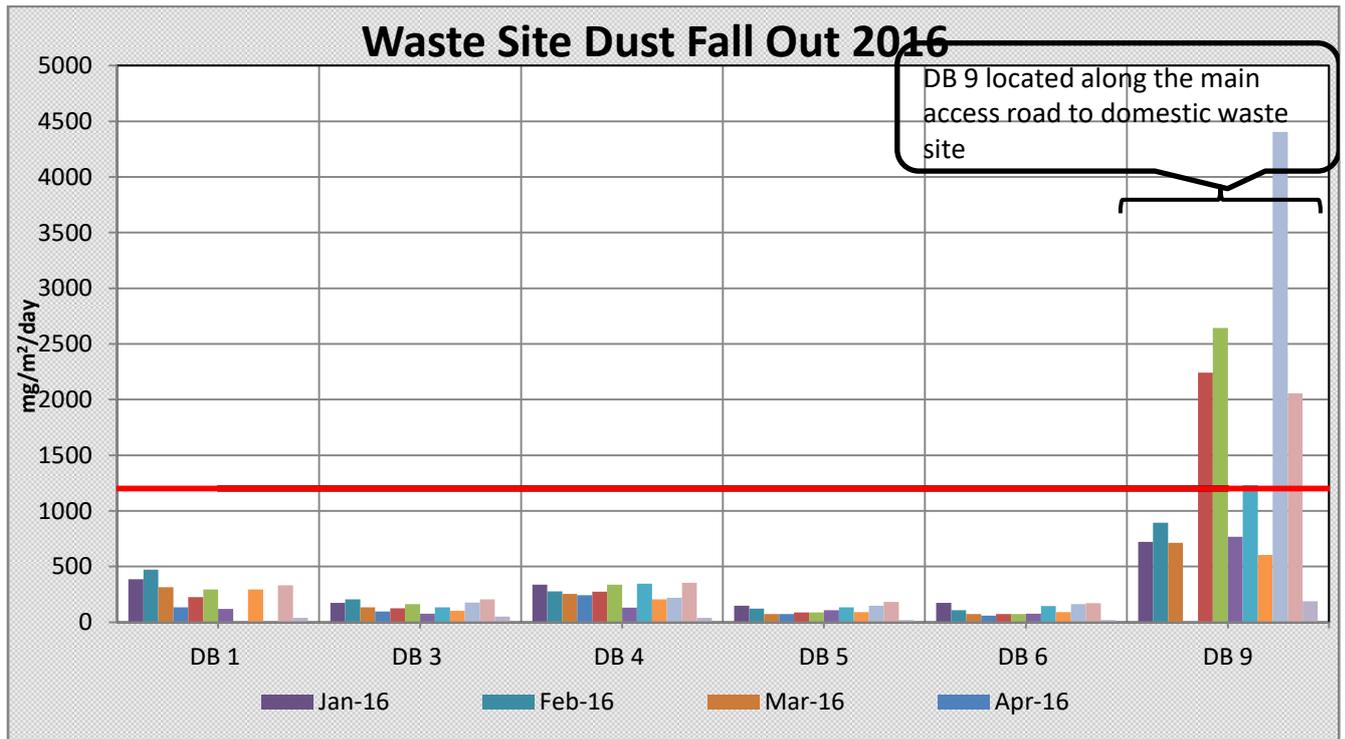
Figure 16: Dust fall out monitoring results

The data indicates that the fence line dust fall out levels is acceptable but the internal area located near the main access road to the waste site facilities exceeds the dust fall levels significantly. The major sources in the area are the roads, the new waste site, the coal storage site and other raw material storage areas and the Sinter Mixing bed.

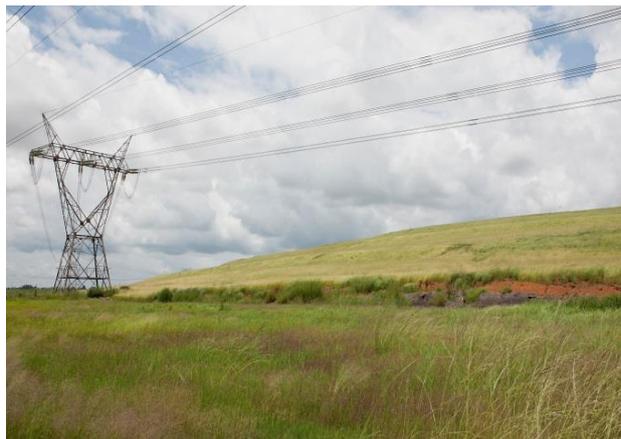
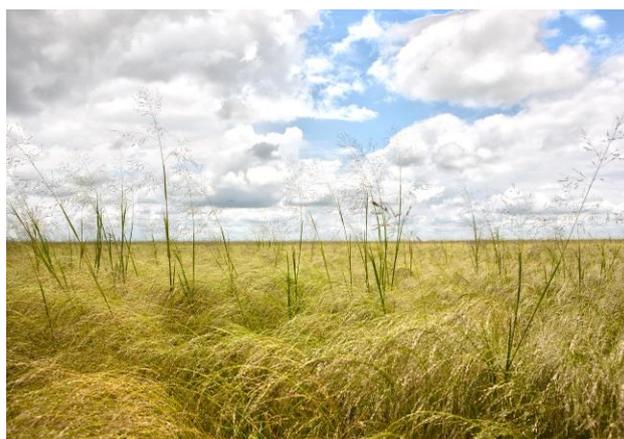
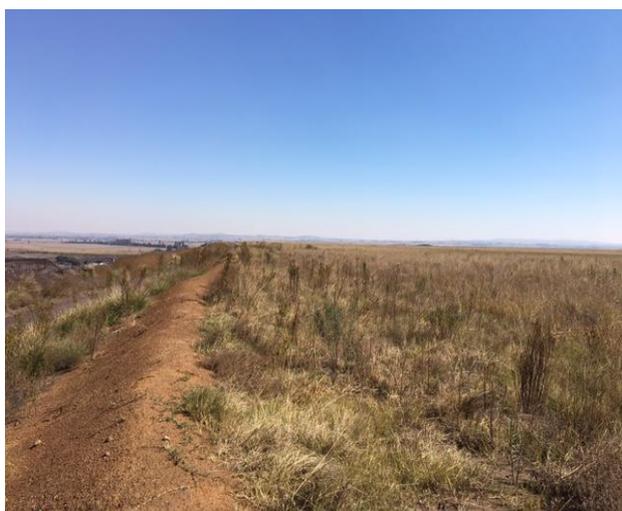
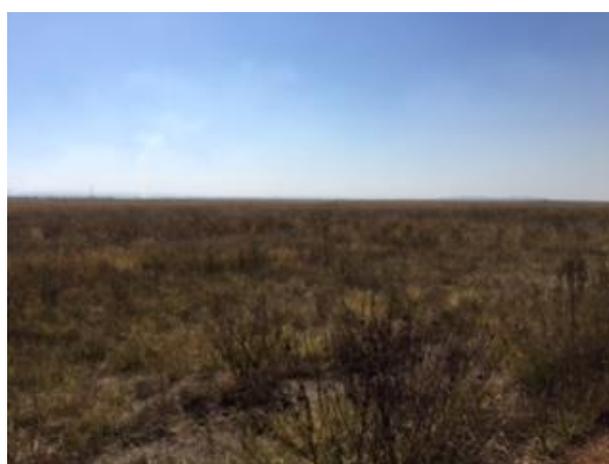
Photo 6, 7, 8 & 9 Remediation Phase 1, 2 & 3

Phase 1 of the remediation of the old waste disposal facility has been successfully completed in 2010. Sufficient vegetation has been established in 2011 and no significant issues detected to date. The vegetation in general seems to have established well with sparse invader grass being present, which is not of great concern. No evidence of erosion was observed during the site visit and the storm water collection and down Shute systems are functioning effectively.

Phase 2 of the remediation of the old waste disposal facility commenced in 2011 and was completed in March 2012. Sufficient vegetation has been established in 2011 and no significant issues detected to date. The vegetation in general seems to have established well with sparse invader grasses present which is not of great concern. No major erosion has been observed and the area around the tip station creates a good impression from an aesthetics perspective.
